Site 276 Kent's Island Creek

Great Marsh Coastal Wetlands Restoration Plan
Rapid Technical Assessment Site 276

Site # 276
Kent's Island Creek

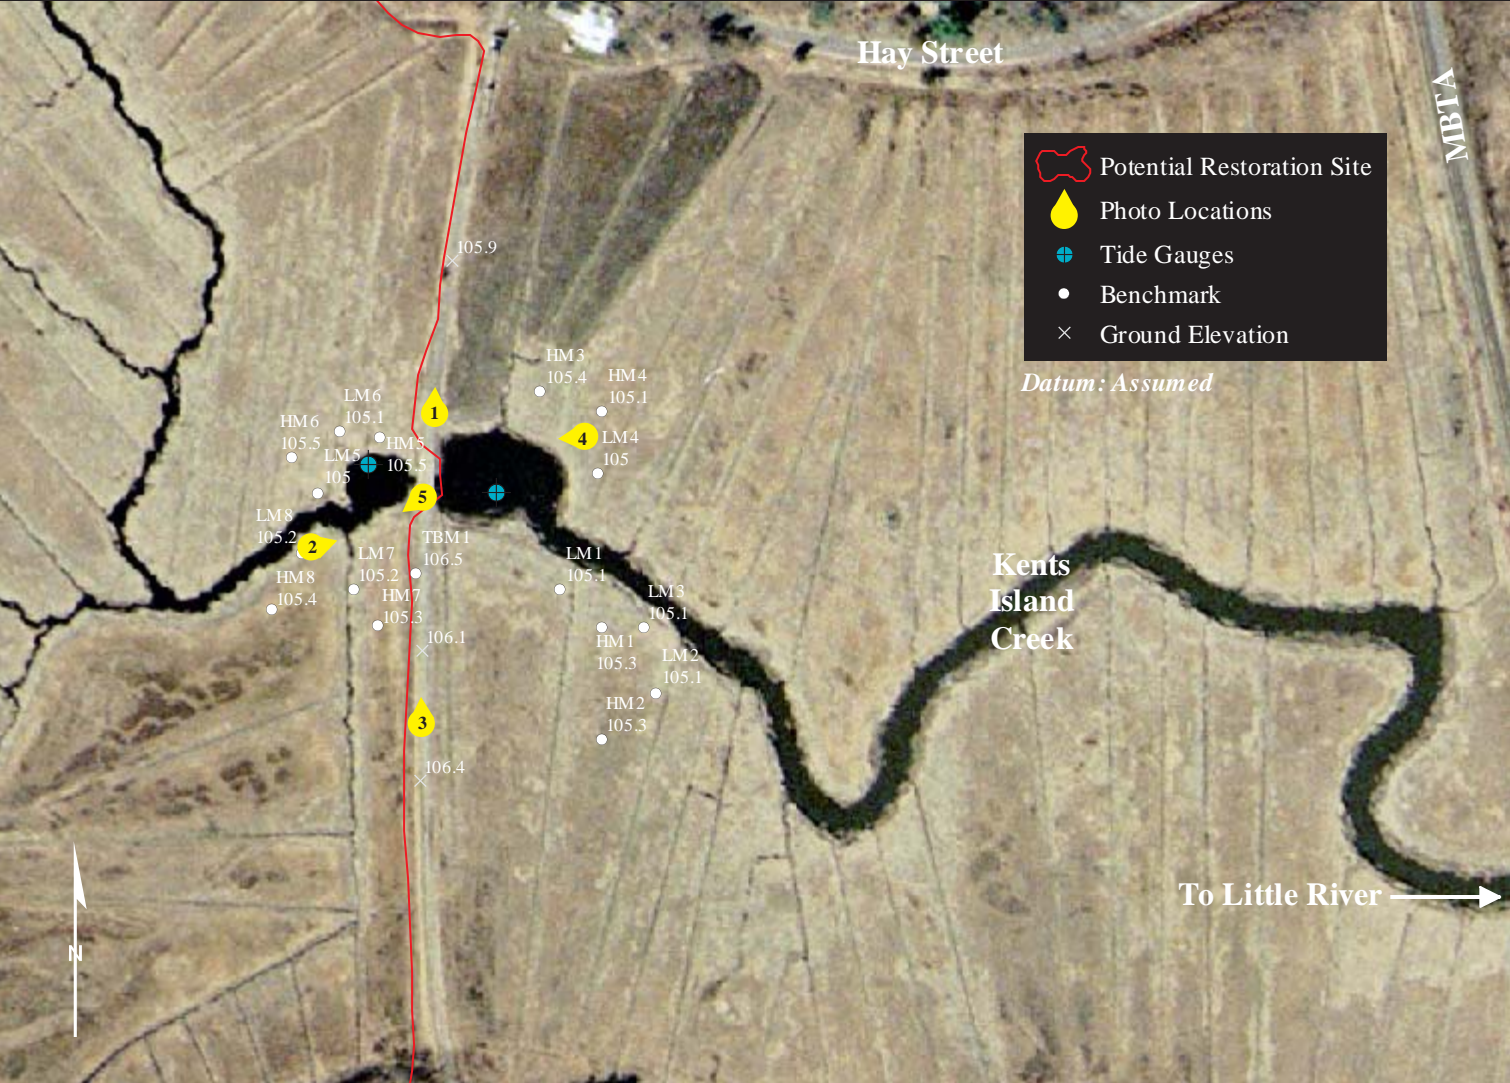
Structure conditions: The Kent's Island access road is in poor condition with substantial pavement degradation especially along the western shoulder due to scour when the road is overtopped during storm events. The low points in the roadway are only approximately 0.5 ft higher than the elevation of the adjacent high marsh. Most of the roadway is approximately 1.0 ft higher than the elevation of the adjacent high marsh. The access road is typically 12 feet wide with gravel shoulders. The bridge crossing consists of concrete deck with steel/Timber beams on stone abutments. The span is approximately 32 ft long with a width of 13 ft. The bridge deck and abutments are severely deteriorated from scour and lack of routine maintenance. Eroded stone from past structures at the crossing have reduced both the width and depth of the effective flow path. Stone in the base of the creek under the bridge deck is approximately 2.8 feet above the downstream creek elevation which causes substantial impoundment within the creek during ebb conditions.

Photo 1 - Access Road North of Bridge Crossing Viewing North
